AFRO 4000 LOCOMOTIVES : INSPECTION AND VERIFICATION REPORT

REFERENCE	RSR/INSPECTION/AFRO 4000/MWC550	
OPERATOR	PASSENGER RAIL AGENCY OF SOUTH AFRICA (PRASA)	
INSPECTION AND VERIFICATION	INSPECTIONS AND TESTS FOR THE AFRO 4000 LOCOMOTIVES	
INSPECTION AND VERIFICATION DATE	November 2015	
INSPECTION AND TEAM COMPILED	TEAM MEMBERS	SIGNATURE
	MR JOSEPH NETHATHE (Pr. Eng.) (Head: Rolling Stock)

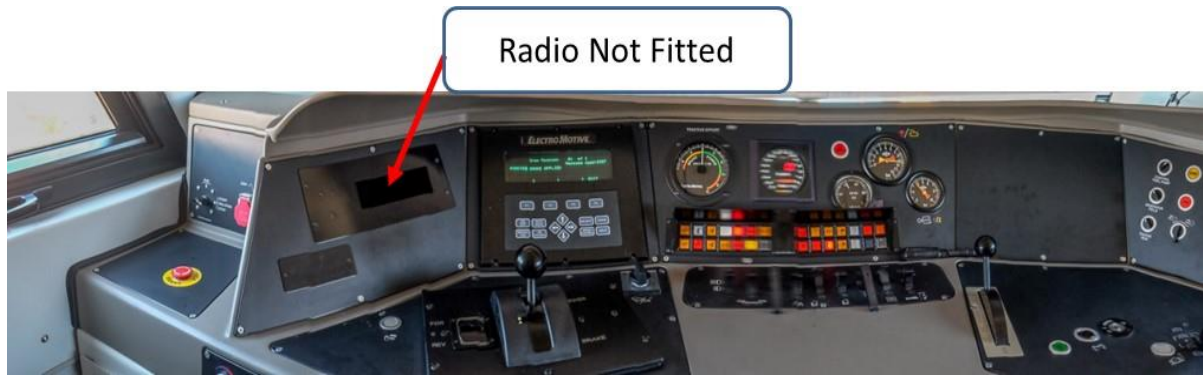
Picture 1: AFRO 4000 Cab Layout

Of the 13 locomotives, only one is equipped with a radio communication system. The absence of an appropriate communication system results in the use of unreliable communication methods and sometimes no communication at all. The picture below shows where the radio communication system should have been fitted

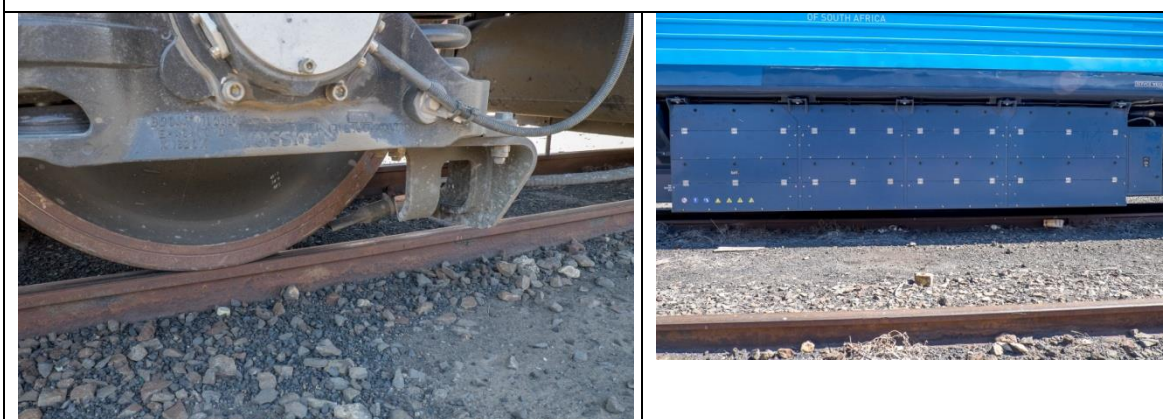
Wheel and sand pipe dispatch point

Battery packs clearance from the top of rail

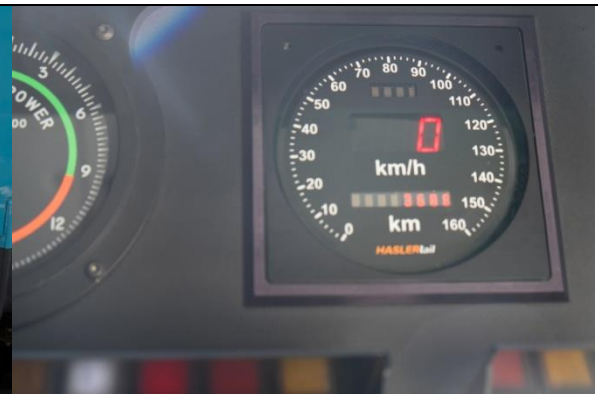
Cab view with the locomotive mileage indication

All the locomotives have already covered significant mileage, with AFRO 4001 and AFRO 4004 having travelled the most at over 12000 km each.

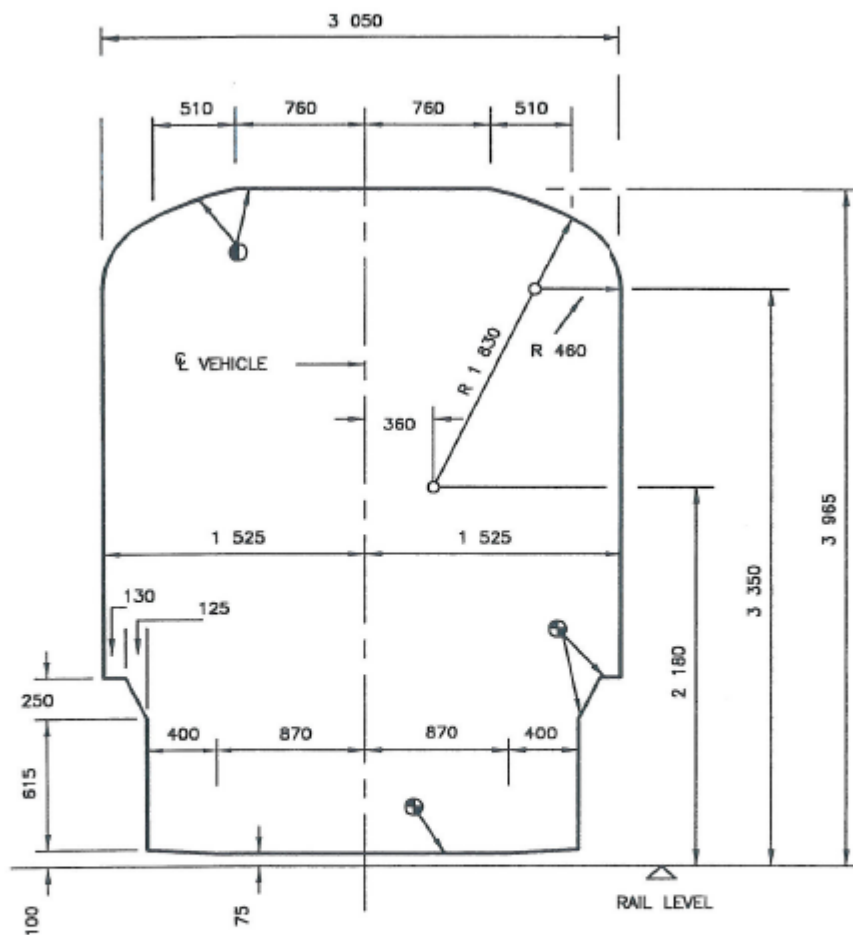
Vertical Static Clearance

VEHICLE GAUGE :
1 065mm TRACK GAUGE

1. WITHOUT LOAD AND WITH NEW TYRES, VEHICLE MUST NOT BE HIGHER THAN THIS OUTLINE.
2. WITH FULL LOAD AND WORN TYRES, VEHICLE MUST NOT BE LOWER THAN THIS OUTLINE.

The vehicle static envelope as per the SARCC Manual for Track Maintenance is shown in Appendix D. The maximum allowable height of the vehicle without load and with new wheels and new springs is 3965mm and the allowable width is 3050mm. The Vossloh AFRO 4000 diesel electric locomotive is 4140mm high and 2850mm wide as noted in the descriptive manual of the locomotive, the highest component being the top of the exhaust silencer. The height figure is consistent with the physical measurements which were conducted using a steel tape measure during the inspection of these locomotives. It1 0 0 1 520.18 675.34 Tm1 0 0t 0 1 20095.2insp10 0T35TJo
